**DENDROCHRONOLOGICAL ANALYSIS OF OAK
TIMBERS FROM BROTHERHOOD HALL,
CHURCH STREET, STEYNING,
WEST SUSSEX, ENGLAND**

Tree-Ring Services Report: SYBH/15/14

Dr Andy Moir

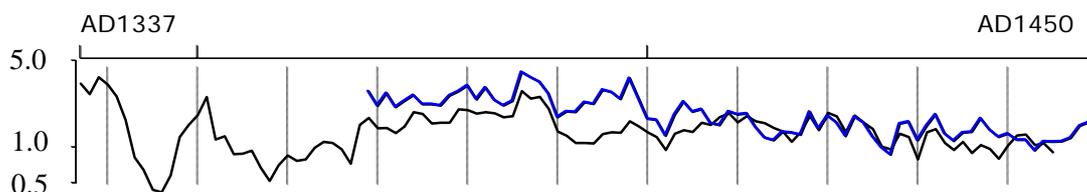
Figure 3: Plot of site chronologies STYNG-BH (blue) and CRANL-VH from Village Hospital - Cranleigh - Surrey (black), which cross-match together with a *t*-value of 10.8

Note: The ring width (mm) is plotted on a (y axis) logarithmic scale using a common axis for both samples.

This site chronology was found to produce consistently high t -values against reference chronologies (**Table 2**) and to visually cross-match (**Figure 3**), with the first ring of the series at AD 1369 and the final ring of the series at AD 1450.

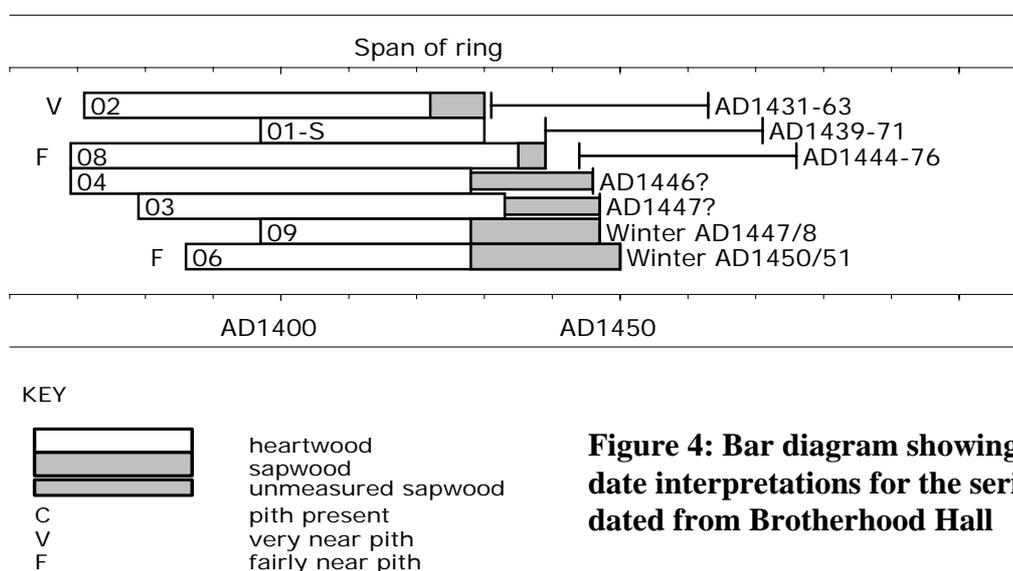
Figure 4: Bar diagram showing the date interpretations for the series dated from Brotherhood Hall

The sapwood allowance used to calculate the felling dates now discussed is presented in **Table 3**, and the bar diagram (see **Figure 4**) helps to demonstrate the findings visually.

Brotherhood Hall produces two precise felling dates and two probably precise felling dates. Under the microscope, full sapwood on samples SYBH09 and SYBH06 occurs with the complete development of the final ring, indicating that the source trees were felled in the winters of AD 1447/8 and AD 1450/51, respectively. Samples SYBH04 and SYBH03 were probably felled in AD 1446 and AD 1447, respectively. The felling-date ranges produced from three other samples dated are compatible with these precise fellings, and together this provides strong evidence to indicate that construction occurred in AD 1451, or soon after.
